MONTARA WATER AND SANITARY DISTRICT AGENDA

For Meeting Of: **March 27, 2025**

SUBJECT: Review and Possible Urgency Actions Concerning Seal Cove Critical Geotechnical Hazards Area

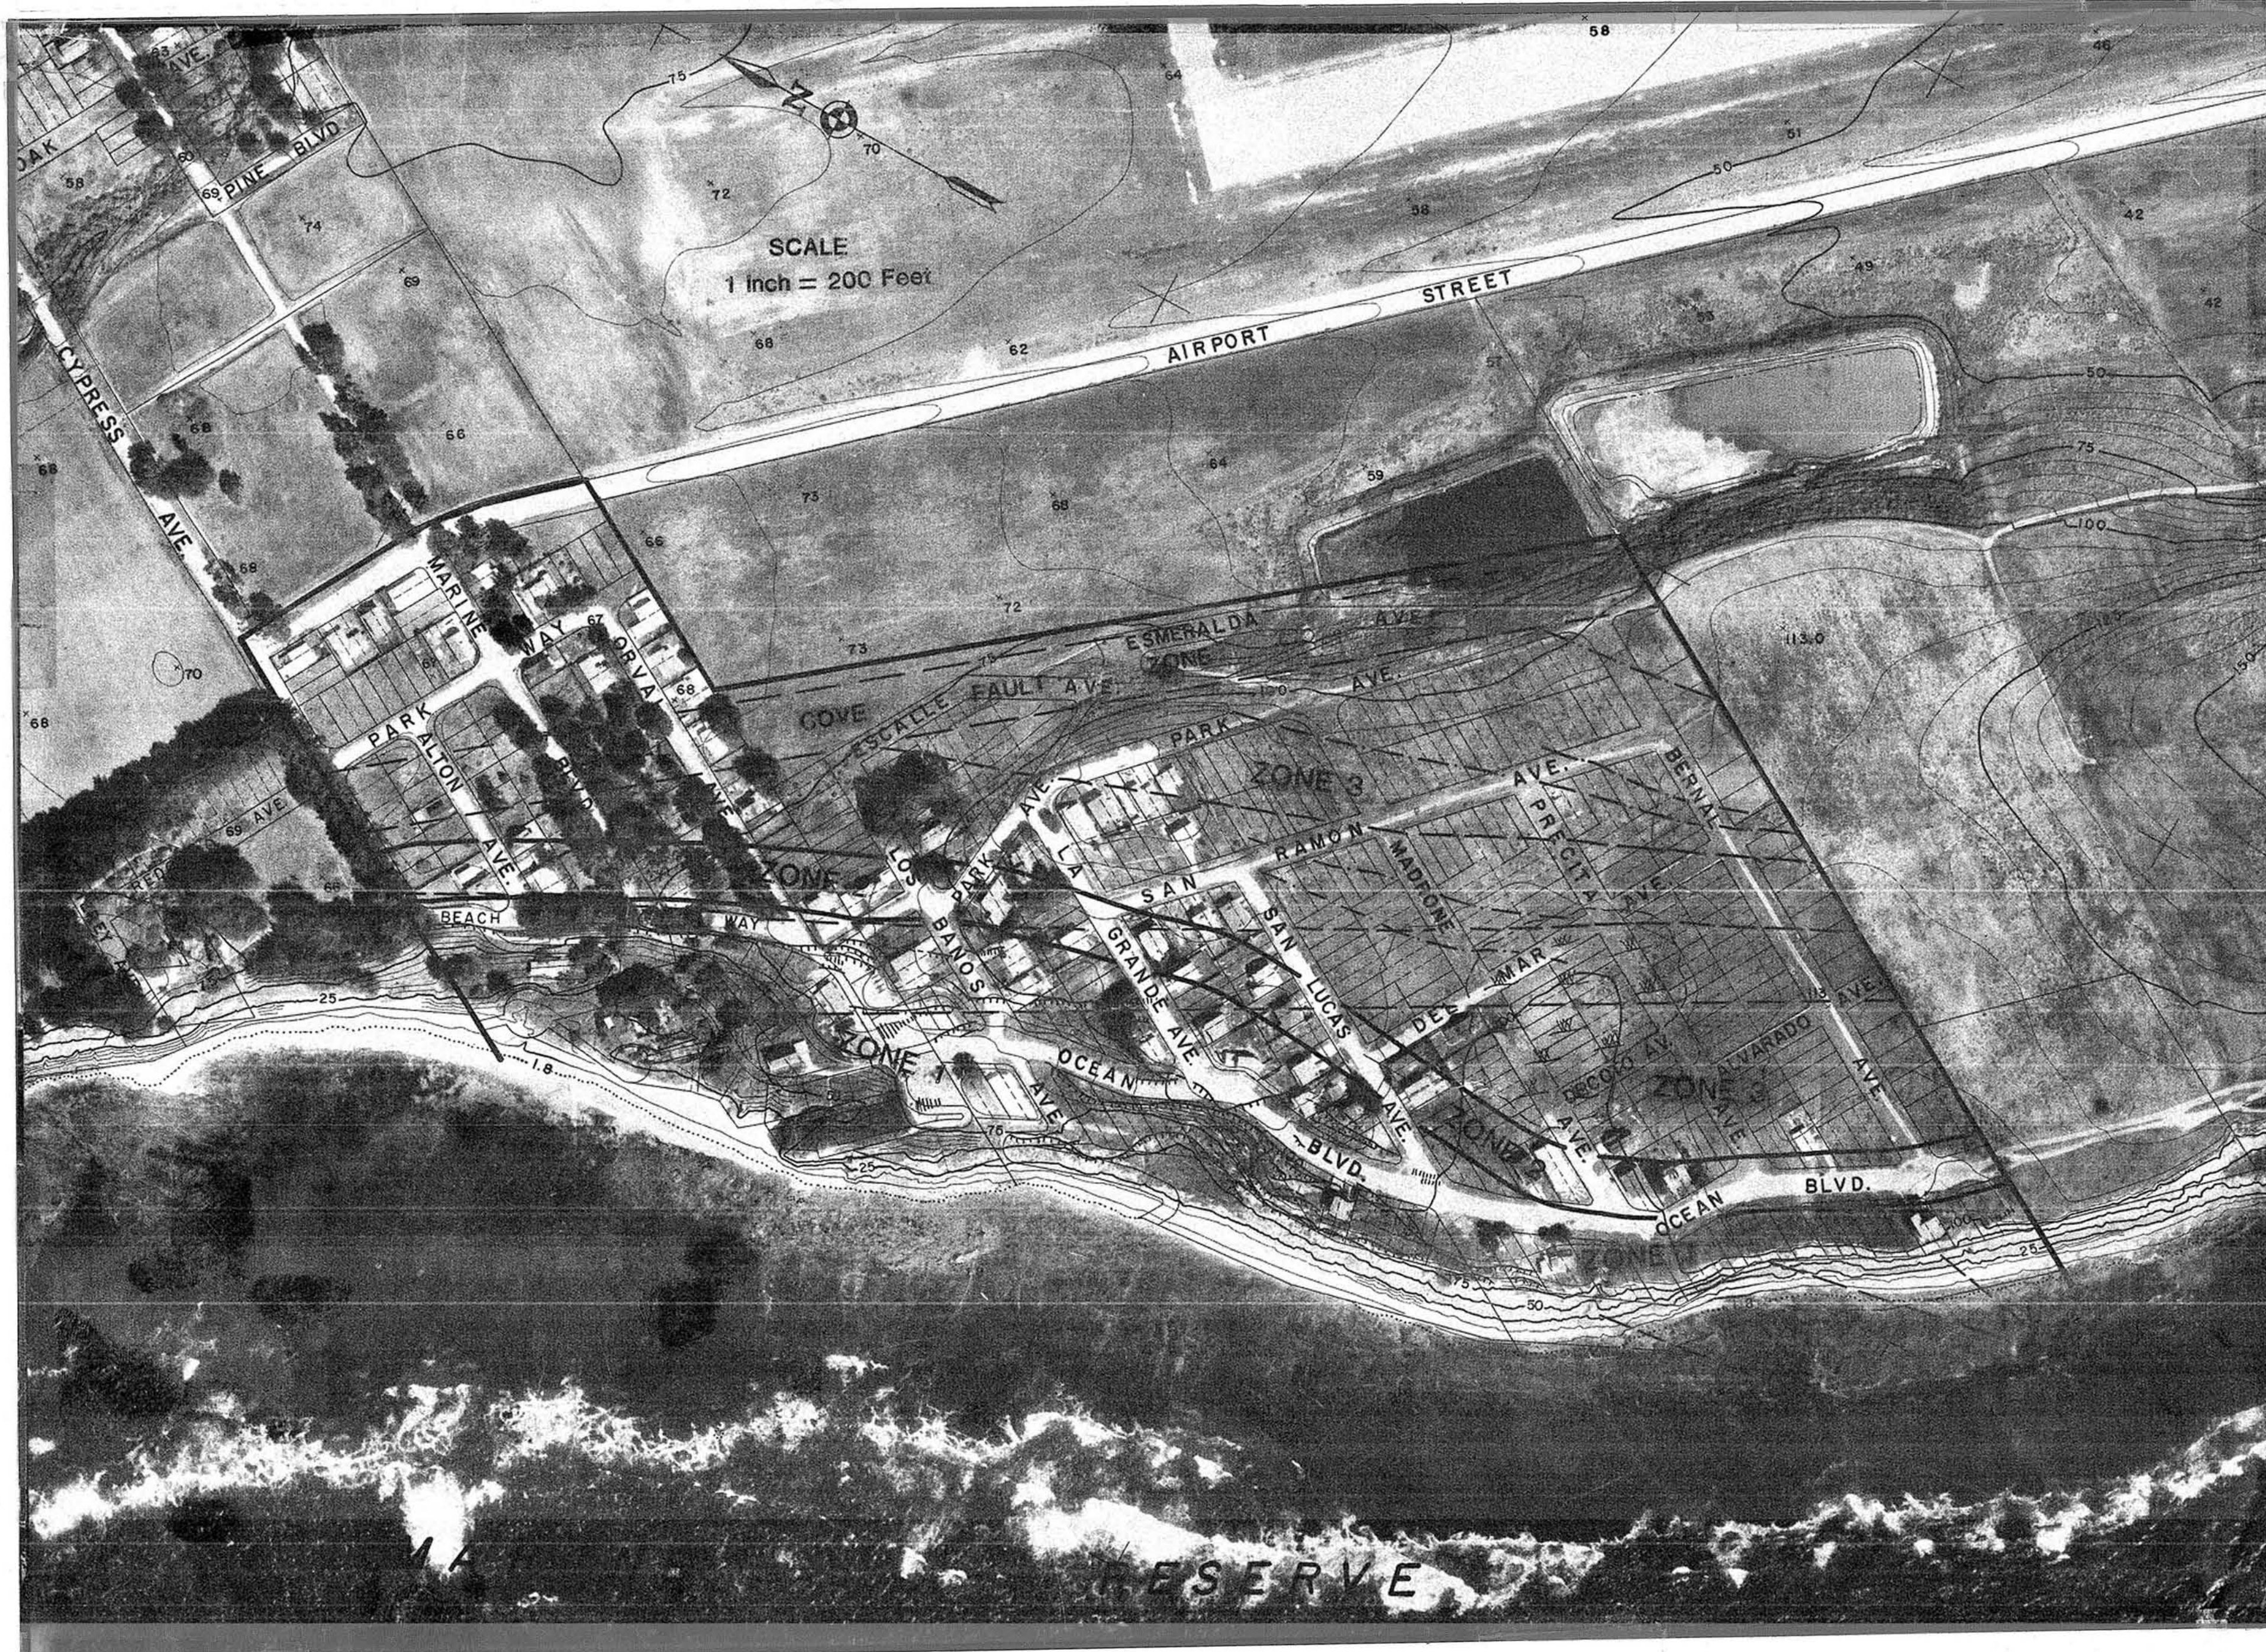
GEOTECHNICAL HAZARDS MAP

GEOTECHNICAL HAZARD ZONE	RISK ASSESSMENT	REQUIRED GEOTECHNICAL INVESTIGATION
ZONE 1 ■ Includes all lands located along the western seaciff that are adversely affected by active landslide processes and accelerated seaciff erosion. The position of the eastern boundary of this zone is established by the easternmost extent of active landsliding plus a setback of 50 feet. The setback zone includes lands which lie outside or east of the active landslides but are expected to experience problems in the future (i.e. 502 years).	UNSTABLE ■ Risk to development in this zone is considered to be extremely high. It is reasonable to conclude that slow progressive landsliding and seaciff retreat will continue, resulting in structural and property damage. This is especially true for structures or utilities located astride active surface breaks. Rapid catastrophic slope failure of the high, steep portion of the seaciff located west of Ocean Boulevard is a clear probability. Such an event could involve the loss of life as well as significant property damage. The feasibility of reducing the risk to acceptable levels is extremely low. ★ No additional development should be allowed in this zone.	■ No investigation deemed feasible due to the severity of the instability.
